Cobra Motorcycle Mfg.

TSB0406: King Rear Shock

December 5, 2005

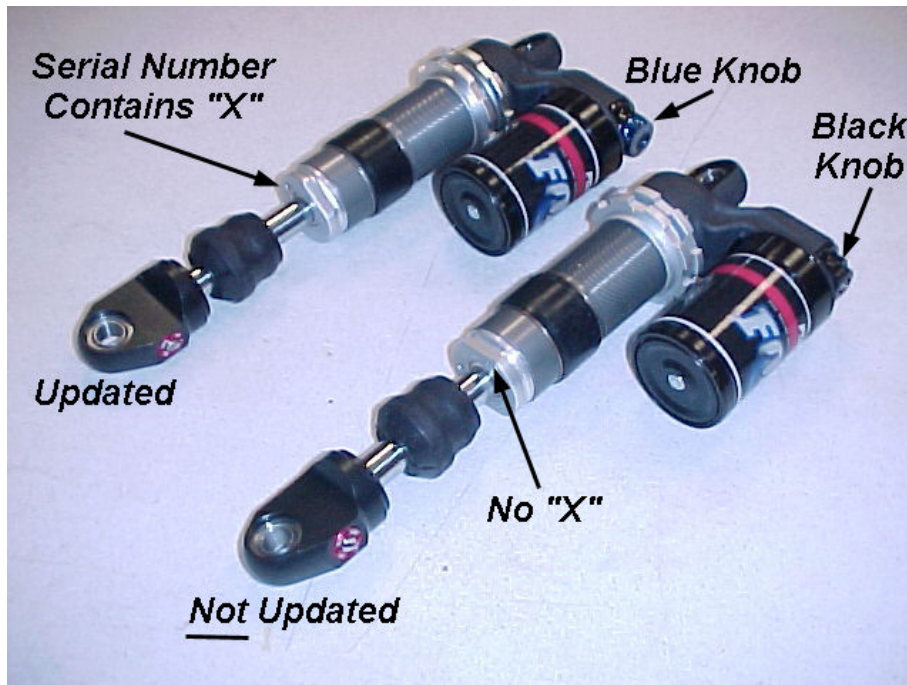
Early King 2006 models have a rear shock with in improperly installed o-ring between the shock body and top piece. This can allow the unit to separate, causing loss of oil pressure, and improper operation. If the Fox shock on your 2006 King does not have the identification marks shown below you must send your shock to Fox for a replacement, free of charge.

Please contact Amanda Keel at Fox to arrange the shipping and exchange of your King shock at no charge to you.
