## Cobra Motorcycle Mfg.

## TSB0710: Clutch washer, bolt, & arbor

December 14, 2009

# Technical Service Bulletin

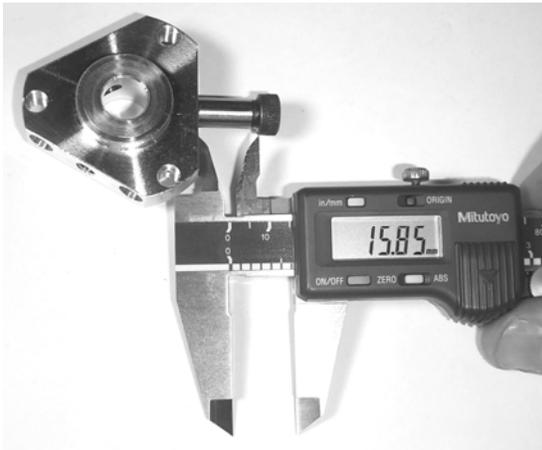
Figure 1

- 1) Amount of wear on shoes (this is difficult to measure and can only be approximated by the step in the shoe where it rides outside the basket – new shoes will not have one, old shoes will have a large one).
- 2) Effective length of the shoulder on the clutch arbor bolt (see figure 1). Nominal is 15.85mm (0.624"). As this decreases, the spring stack needs to decrease equally. This can change due to the shoulder bolt 'setting' into the arbor (see figure 2)

If your effective shoulder length is off, or your shoes are worn, adjust the height of your overall combined spring stack accordingly (i.e. if your effective shoulder length is 0.5mm short of the 15.85 measurement, decrease the overall combined spring stack height by 0.5mm, or if your shoes are worn by 0.5 mm, increase the overall combined spring stack height by 0.5mm).
