Cobra Motorcycle Mfg.

TSB0811 2011 Connecting Rod Wrist Pin Bearing

Technical Service Bulletin

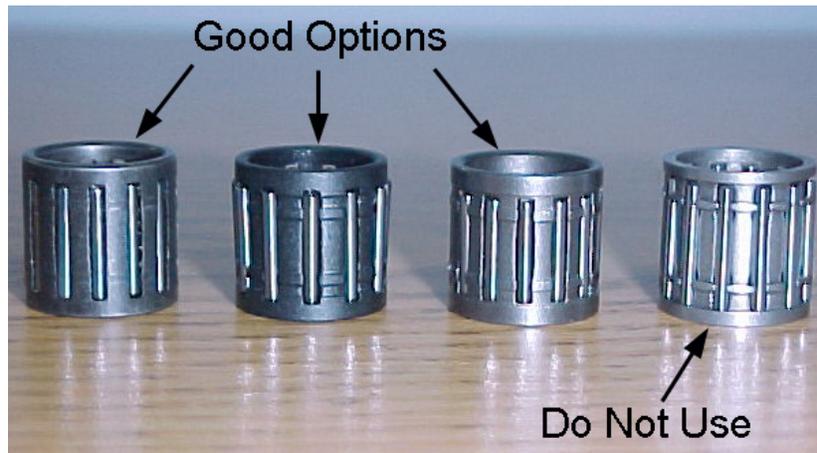
These bearings have recently started failing in use when the cage holding the needles breaks, causing substantial damage to the piston, cylinder head, cylinder, and crank. Engines with this bearing should not be used any further until this bearing has been replaced.

The bearings are noticeably different as can be noticed in the picture below.

Customers needing an immediate solution can also purchase an acceptable wrist pin bearing from Wiseco (their part number B1041). Be sure to replace the wrist pin circlip with a new one for reassembly (Wiseco part number CW12)
