## TSB1006: King & CM Engine Case Bolts

January 27, 2006

# Technical Service Bulletin

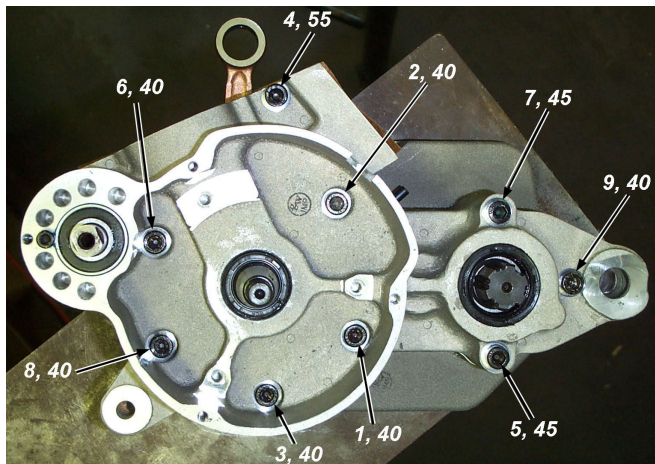
A couple instances of air leaks in 2006 King & CM engines have been attributed to improper machining of the threaded holes that the engine case bolts screw into. They are not tapped deep enough for the bolt to apply the proper torque to the engine cases & center case gasket.

The easiest way to determine if your engine may be suspect is to recheck the torque of case bolt #4 (the 6 x 55mm bolt) located near the inlet. If upon checking the torque of the bolt at the proper torque (12 Nm or 105 in-lb) the bolt tends to 'unwind' after releasing the torque, it is incorrectly bottoming in the threads and not applying full load to the clamping of case & gasket. If the bolt remains fixed after applying torque, it is correctly applying the clamping load to the case & gasket.

As the bolt to thread depth clearance is the least on the #4 bolt, confirming it's tightness will confirm the rest of the bolts.

If it is determined that the #4 case bolt is 'unwinding', then remove the case bolts, one at a time, and install a standard 6mm flat washer onto the bolt, then reassemble. This has proven to provide adequate clearance in the observed instances.
