Cobra Motorcycle Mfg.

TSB1008 2008 CX50SR (King) Ignition System

January 14, 2008

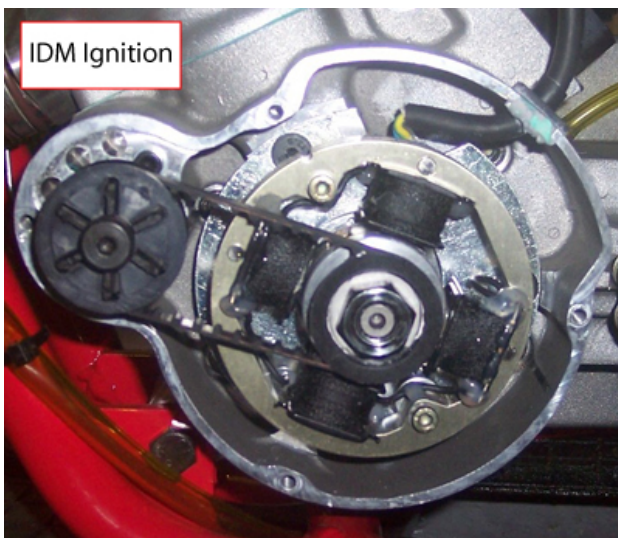
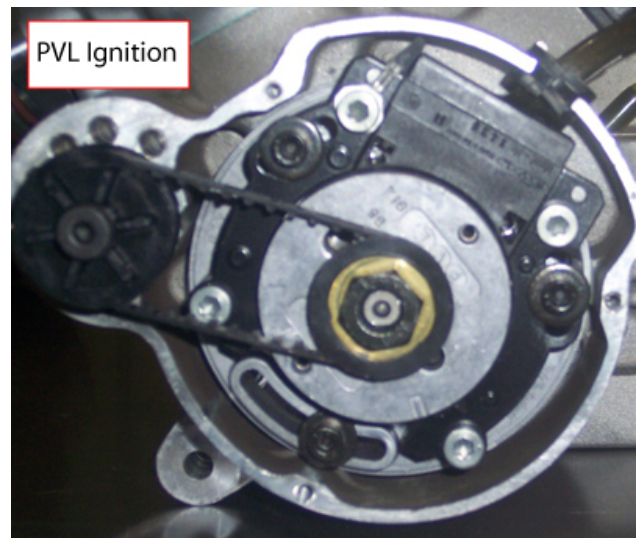
Many 2008 Cobra CX50SR (King) customers are experiencing performance issues with their new motorcycles. These issues include cracking/popping noises, degrading performance, and excessively hot exhaust pipes. These issues have been traced back to manufacturing flaws with the new IDM brand ignition system. Because of the time associated with getting these issues sorted out, Cobra is switching production of the 2008 King over to the PVL brand ignition system (the same design used on 2007 model King motorcycles).

To install the PVL system on the 2008 King simply remove the old hardware, and bolt on new (an updated Cobra universal puller will be required to remove the ignition rotor). The timing of the new PVL system will have to be set properly during installation.
