# Technical Service Bulletin

**Cobra Motorcycle Mfg.**

## TSB1208 CX65 Clutch pressure plate

March 6, 2008

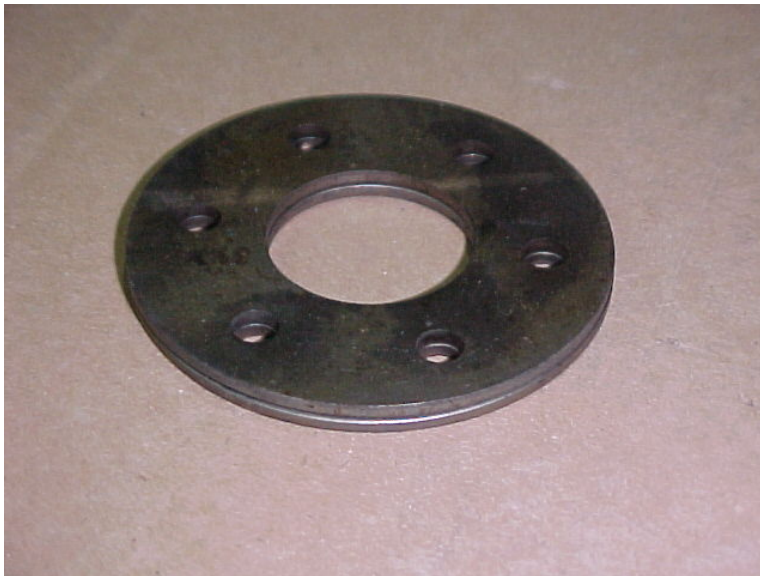
If CX65 customers experience bending of the clutch pressure plate (ECDC0071) or have the clutch hydraulic system loose fluid (into the transmission), the short term fix is to install two ECDC0071 pressure plates. Shortly, Cobra will have available a thicker plate setup (ECMU0224).
