# Technical Service Bulletin

**Cobra Motorcycle Mfg.**

## TSB1512 Solenoid Care on 2012 CX65

April 25, 2012

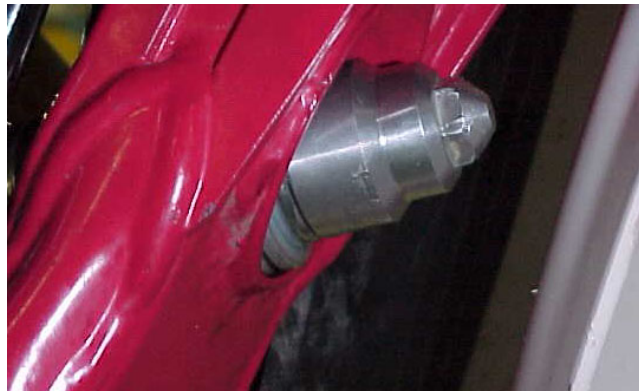
In order to keep solenoid wires from breaking, care must be taken not to rotate the solenoid housing when loosening the power valve cap. The cap does not need to be installed very tightly, in fact if the sealing o'ring is lubricated, then hand tight will be sufficient.

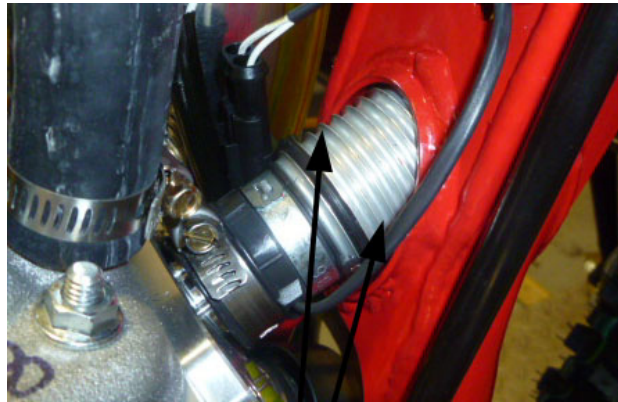
squeeze here if necessary

To avoid solenoid rotation, it may be necessary to squeeze the solenoid body with a tool.
