**Cobra Motorcycle Mfg.**

## TSB01611 New style Clutch Shoes

# Technical Service Bulletin

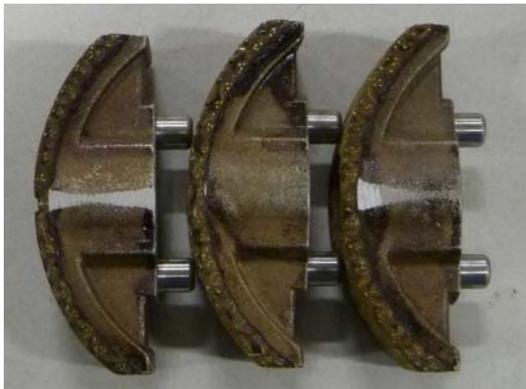
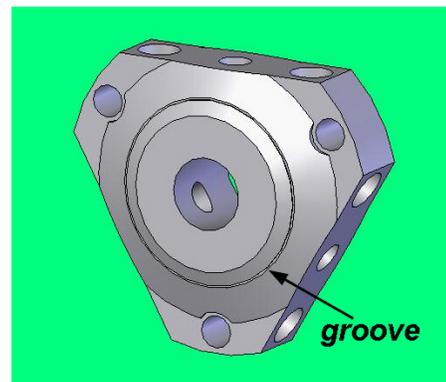
Cobra is switching over to a new manufacturing process to produce the aluminum base for our clutch shoes (see picture below left).

This style of shoes are slightly wider and require an ECMU0040 (0.8mm or 0.030" spacer) between the clutch arbor and the clutch basket to avoid undesired contact. If the shoes are used with the latest clutch arbor (shown on the right, with the identification groove) then there is space on the crankshaft for an ECMU0040 between the arbor and the basket as well as one behind the basket as they always has been. This will insure that the shoes have corner clearance with respect to the radius inside the clutch basket (see below).

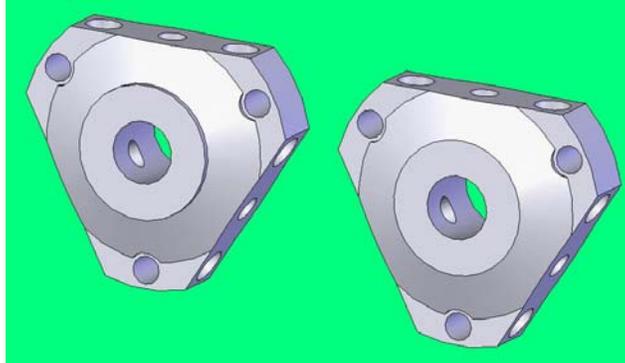
If the shoes are being applied to an older arbor (shown above without the identification groove), the ECMU0040 (0.8mm or 0.030" spacer) is still required between the arbor and the basket but there will likely not be space for the usual shim behind the basket. In fact depending on the age of the arbor, it may not be possible to get a shim between the arbor and the basket. If this is the case, then it may be necessary to take a file and create a 1.0mm (0.040") chamfer in the edge of the shoes facing the clutch basket as shown below.

If there is not enough clearance to even install the thin shim (0.4mm, 0.015") then the arbor must be replaced because there is no way to insure that the shoe won't just rub in the inside surface of the basket.

For customers with engines built prior to 2006, they must purchase CCMU0029 clutch arbor before using these clutch shoes and washers.
