Technical Service Bulletin

Cobra Motorcycle Mfg.

TSB01711 Top Triple Clamps on King and CX65

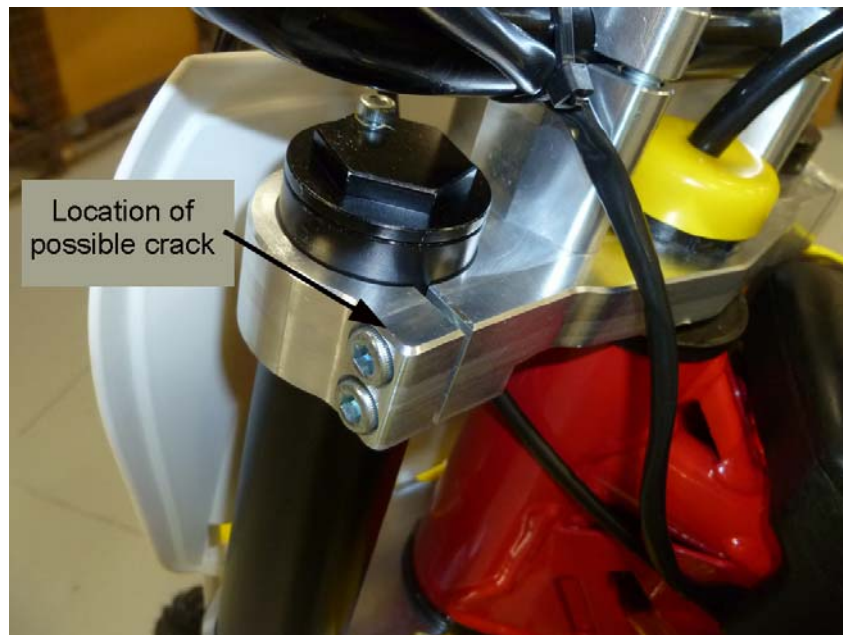
There have been some rare occurrences of the top triple clamps developing a stress crack near the pinch bolts on both 2011 King and CX65. The picture below shows where to look.

Please contact Cobra Customer Service if you have had this occur.
