Technical Service Bulletin

Cobra Motorcycle Mfg.

TSB2212 King and JR Intake Screws Re-tightening

June 25, 2012

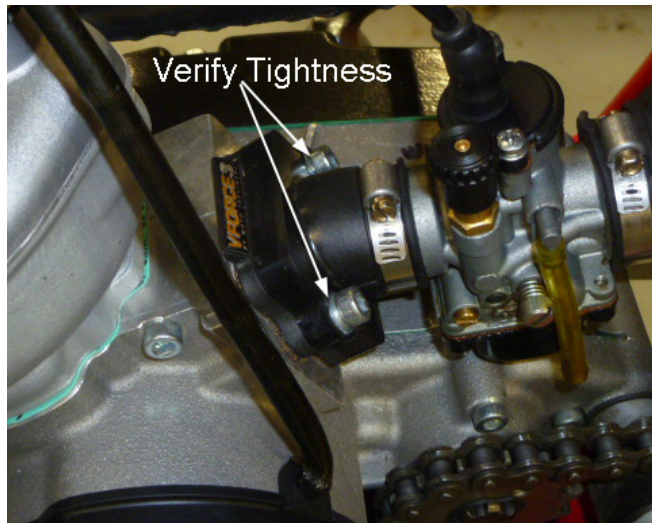
The two socket head cap screws that secure the intake boot to the engine on the 2012 King and CX50 JR may require retightening over time. The proper torque is 4.5 ft-lb (55 in-lb, 6 Nm). Insufficient tightness on these screws may cause an air leak.

Air leaks downstream of the carburetor can cause jetting irregularities. This can lead to inconsistent throttle response, and in the worst case scenario engine failure.
