Technical Service Bulletin

Cobra Motorcycle Mfg.

TSB0404: 2004 King potential pinched ignition wire location.

April 2, 2004

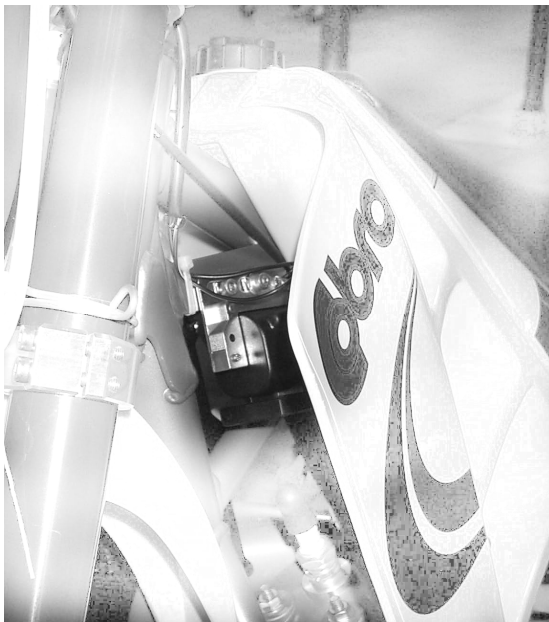
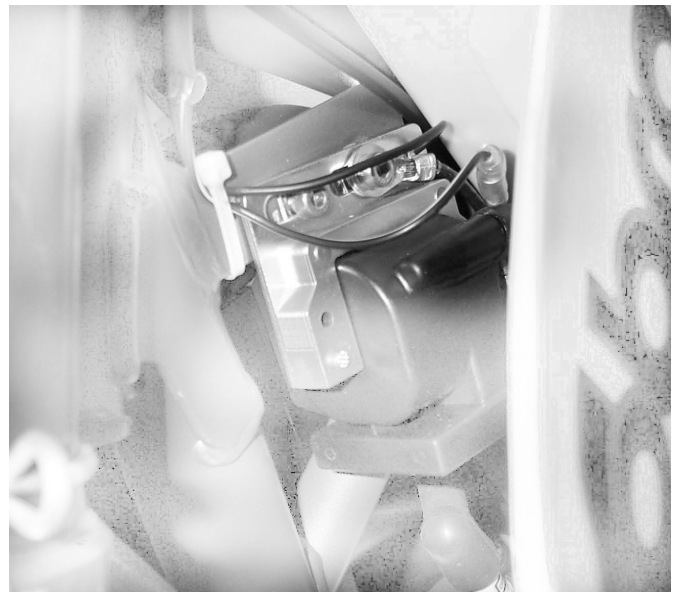
On some of the 2004 model King 50's it is possible that the ignition cut off switch (kill switch) wires, or the stator wires, can get pinched between the ignition coil frame and the gas tank (see picture).

Remove the fuel tank and closely inspect the wire for compromises in the insulation (bare wires, indentations, etc...) Cover any blemishes with electrical tape and reroute the wires such that a generous amount of clearance is insured.
