Technical Service Bulletin

Cobra Motorcycle Mfg.

TSB0613V2 POWER VALVE UPGRADE (REVISED)

December 19, 2012

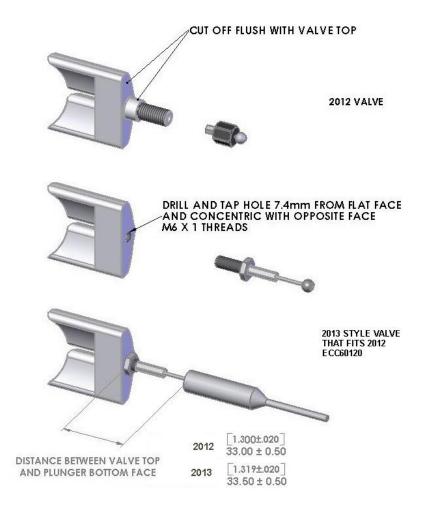
Due to fatigue failures in the CX65 power valve and cable, these components have been upgraded for 2013. Customers can upgrade from 2012 style to 2013 style by machining off the stem from the 2012 valve and inserting a threaded hole (M6 x 1.0 through) in the same location (see picture below).

The cable (ECC60155) and jam nut (HCNJ0601) are available through your dealer or Cobra. Secure the Jam nut on the cable to 8Nm (6 ft-lb).
