**Technical Service Bulletin**

Cobra Motorcycle Mfg.

## 240 Uran Street (517) 437 9100 phone Hillsdale MI, 49242 (517) 437-9101 fax TSB1304: 2004 CM & King secondary shaft bearing retainer

April 2, 2004

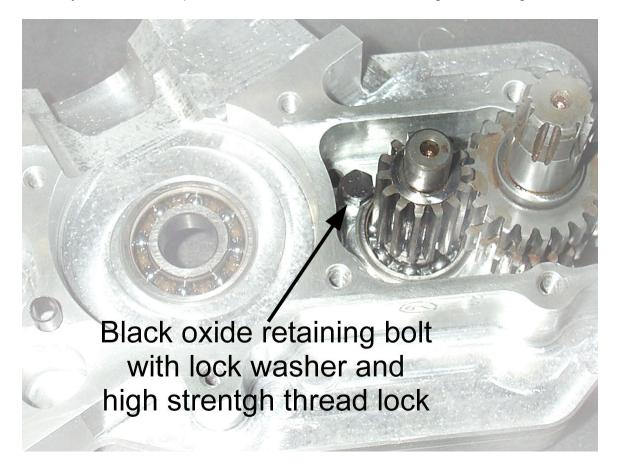
There is a slim chance (but possible none the less) that the secondary shaft bearing retainer (screw) can back out of it's intended position.

If this retainer comes out of position it can cause an immediate stop to the motorcycle and has to potential to cause substantial damage to the engine.

The early button head screw (with high strength thread locking agent) has been replaced with a black oxide bolt, lock washer, and high strength thread locking agent.
