Technical Service Bulletin

Cobra Moto, LLC

TSB0426 update 2 CX65 Cylinder Stay Bracket

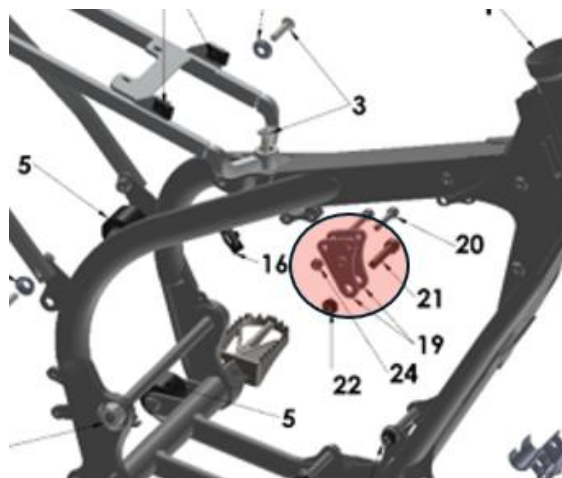
2024 – 2026 CX65's have two cylinder stay brackets (FCC60117) that are too rigid together. Combined they subject the frame and back of cylinder to too high of stress.

The "S" bracket is of insufficient strength. For now use only 1 of the aluminum (FCC60117) brackets and not two of them. They will ultimately fail but its easier and quicker to replace than a frame.

Old dual bracket

In the meantime, please check the backbone of your frame for signs of cracks (black powder typically visible along the edge of a weld, or if the radiator cap is becoming difficult to remove due to proximity to upper triple clamp. Either of these may be signs of the frame needing replaced.
