Technical Service Bulletin

Cobra Motorcycle Mfg.

TSB0406: King Rear Shock

December 5, 2005

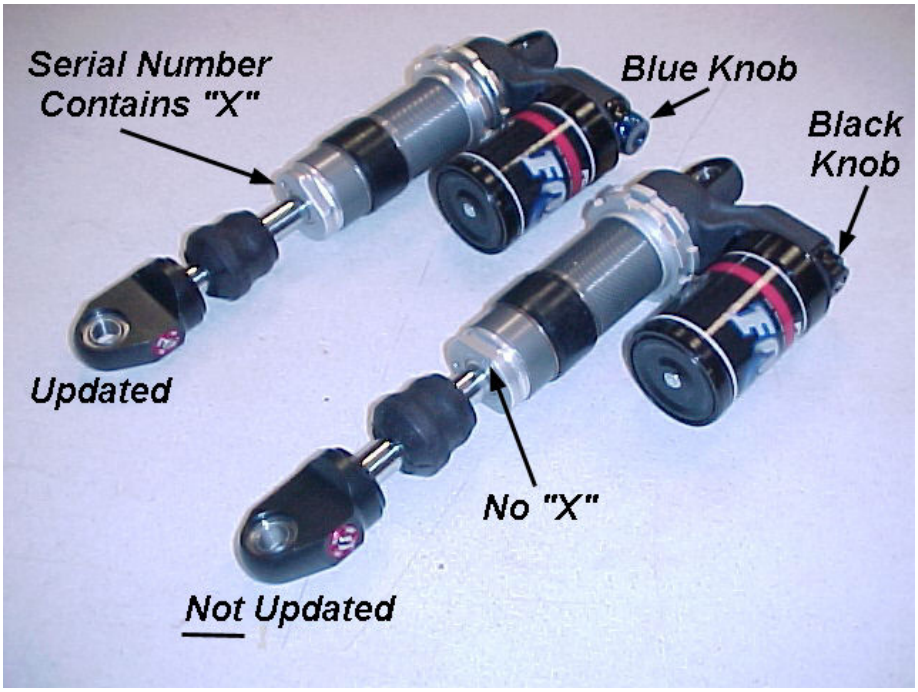
Early King 2006 models have a rear shock with in improperly installed o-ring between the shock body and top piece. This can allow the unit to separate, causing loss of oil pressure, and improper operation. If the Fox shock on your 2006 King does not have the identification marks shown below you must send your shock to Fox for a replacement, free of charge.

Please contact Amanda Keel at Fox to arrange the shipping and exchange of your King shock at no charge to you.
