Technical Service Bulletin

Cobra Motorcycle Mfg.

TSB0613V2
POWER VALVE UPGRADE (REVISED)

December 19, 2012

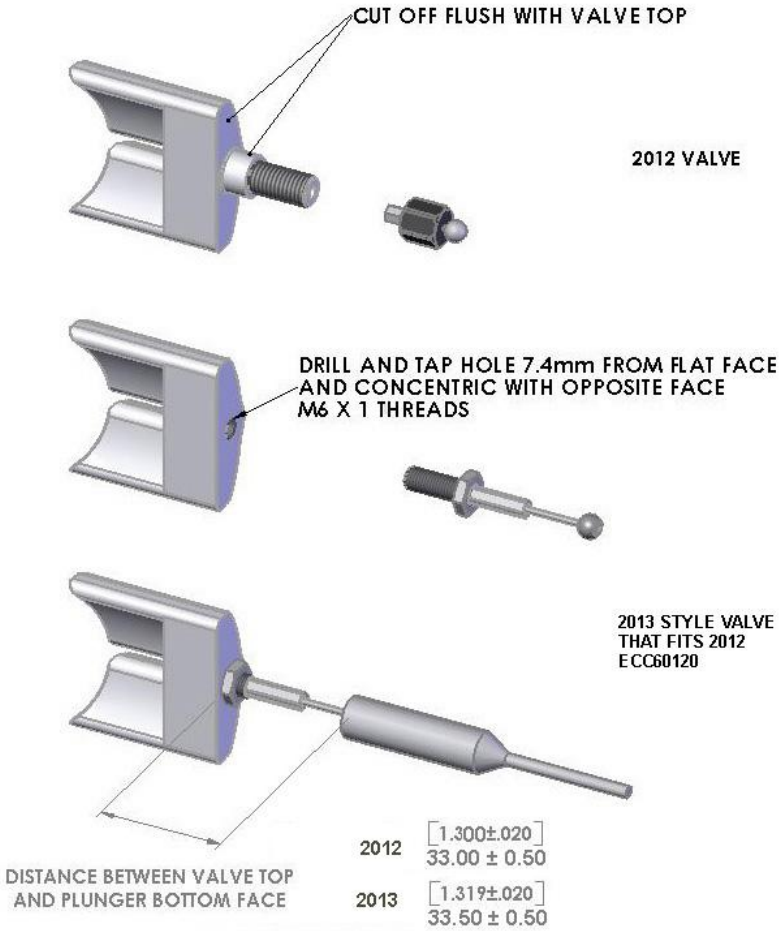
Due to fatigue failures in the CX65 power valve and cable, these components have been upgraded for 2013. Customers can upgrade from 2012 style to 2013 style by machining off the stem from the 2012 valve and inserting a threaded hole (M6 x 1.0 through) in the same location (see picture below).

The cable (ECC60155) and jam nut (HCNJ0601) are available through your dealer or Cobra. Secure the Jam nut on the cable to 8Nm (6 ft-lb).
