Technical Service Bulletin

Cobra Motorcycle Mfg.

TSB1304: 2004 CM & King secondary shaft bearing retainer

April 2, 2004

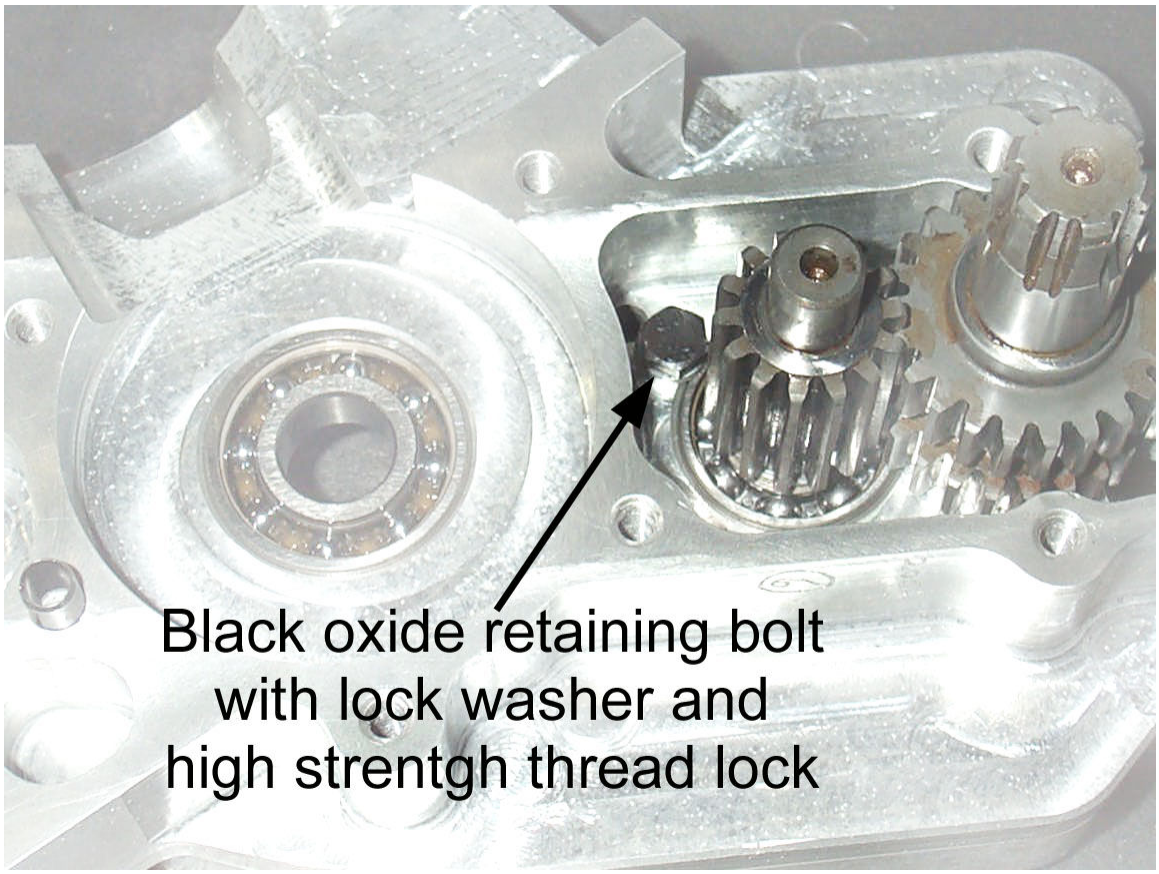
There is a slim chance (but possible none the less) that the secondary shaft bearing retainer (screw) can back out of it's intended position.

If this retainer comes out of position it can cause an immediate stop to the motorcycle and has to potential to cause substantial damage to the engine.

The early button head screw (with high strength thread locking agent) has been replaced with a black oxide bolt, lock washer, and high strength thread locking agent.
