Technical Service Bulletin

Cobra Motorcycle Mfg.

TSB1507: CX65 Airbox Water Protection

May 31, 2007

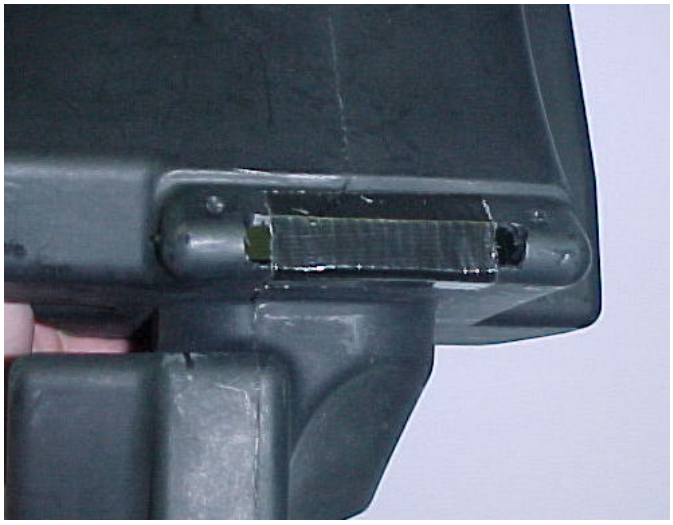
The Airbox on the CX65 has a relatively large area in the bottom for water to drain. In wet and muddy conditions, it is recommended that customers with this style of airboxe use “duct tape” or suitable product to seal the majority of the length of the slot in order to keep water out while still allowing some passage for water to escape if it should happen to get in.
