Technical Service Bulletin

Cobra Motorcycle Mfg.

TSB1512 Solenoid Care on 2012 CX65

April 25, 2012

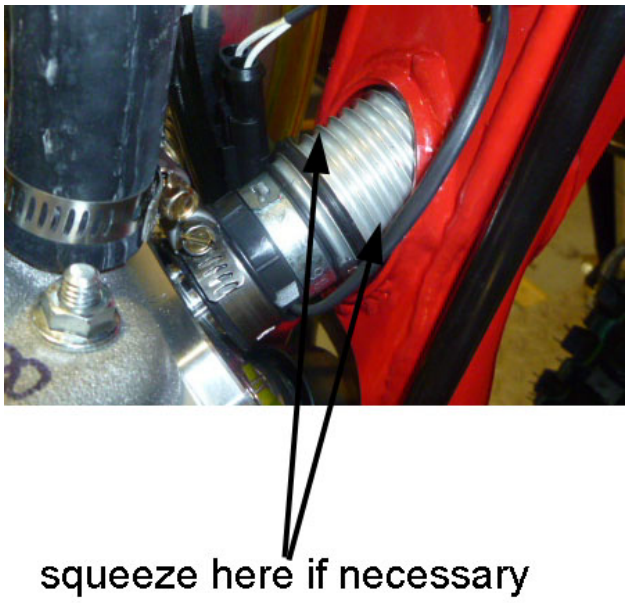
In order to keep solenoid wires from breaking, care must be taken not to rotate the solenoid housing when loosening the power valve cap. The cap does not need to be installed very tightly, in fact if the sealing o'ring is lubricated, then hand tight will be sufficient.

To avoid solenoid rotation, it may be necessary to squeeze the solenoid body with a tool.
