# Technical Service Bulletin

**Cobra Motorcycle Mfg.**

## TSB2212 King and JR Intake Screws Re-tightening

June 25, 2012

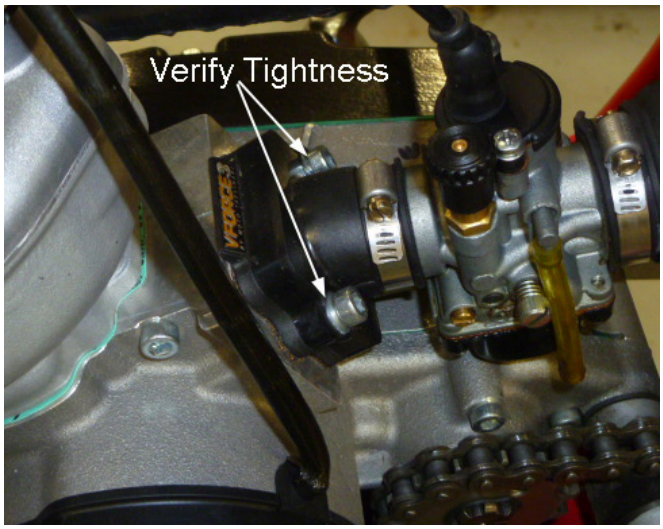
The two socket head cap screws that secure the intake boot to the engine on the 2012 King and CX50 JR may require retightening over time. The proper torque is 4.5 ft-lb (55 in-lb, 6 Nm). Insufficient tightness on these screws may cause an air leak.

Air leaks downstream of the carburetor can cause jetting irregularities. This can lead to inconsistent throttle response, and in the worst case scenario engine failure.
