Technical Service Bulletin

August 23, 2018

TSB0219
2018 CX65 Swingarms

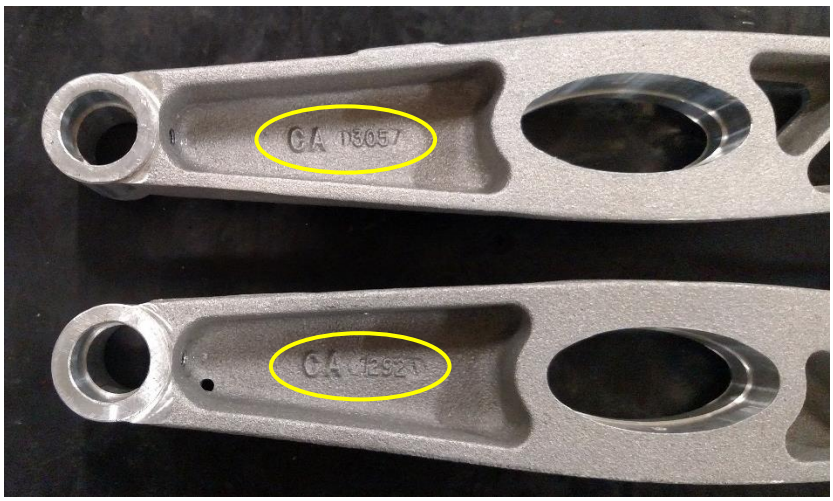
Swingarms produced with casting code CA292 or CA305 are prone to failure. Swingarms with any other casting code including CA087 or any code of 4 digits followed by a letter (like 4132A) are okay to continue using.

To look for casting codes, one should look inside the swingarm side arms behind the swingarm pivot and in front of the shock mount. The codes on the swingarms shown below are CA305 and CA292.

It is recommended that these motorcycles not be ridden until which time Cobra can provide customers updated replacements swingarms. We are scheduling these to start shipping in late September 2018. Please call Cobra Customer Service and have your VIN along with swingarm code.

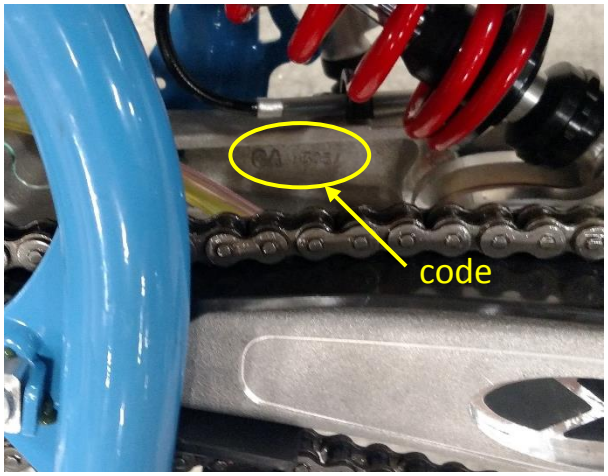
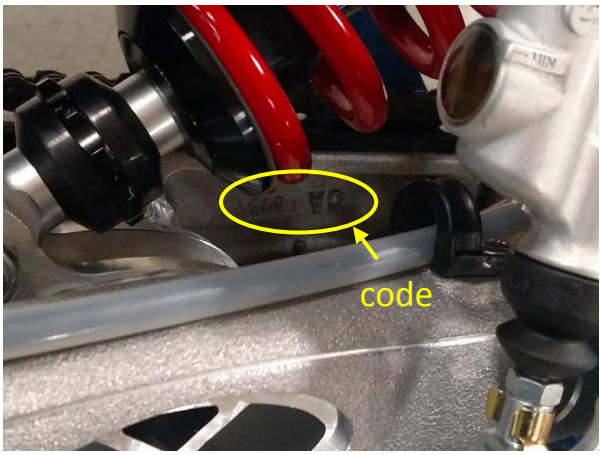
The pictures below show the where the casting codes can be seen on the motorcycle.

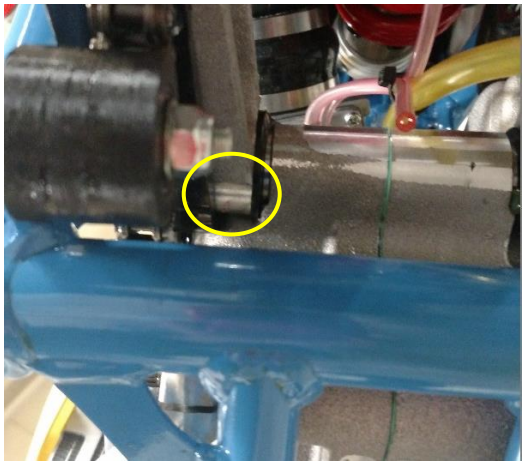
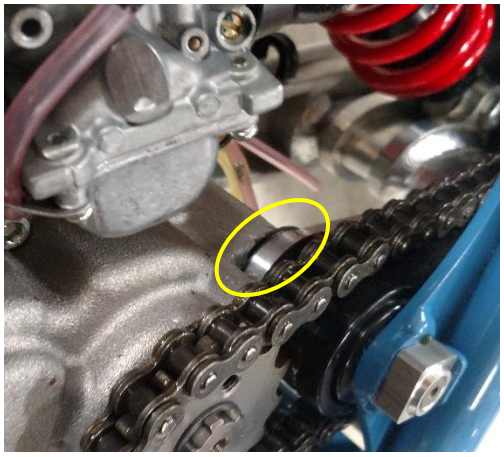
To look for cracks, one must clean thoroughly and then look above and below the swingarm pivot.
