Technical Service Bulletin

Cobra Motorcycle Mfg.

TSB0414 CX65 CDI unit

December 20, 2013

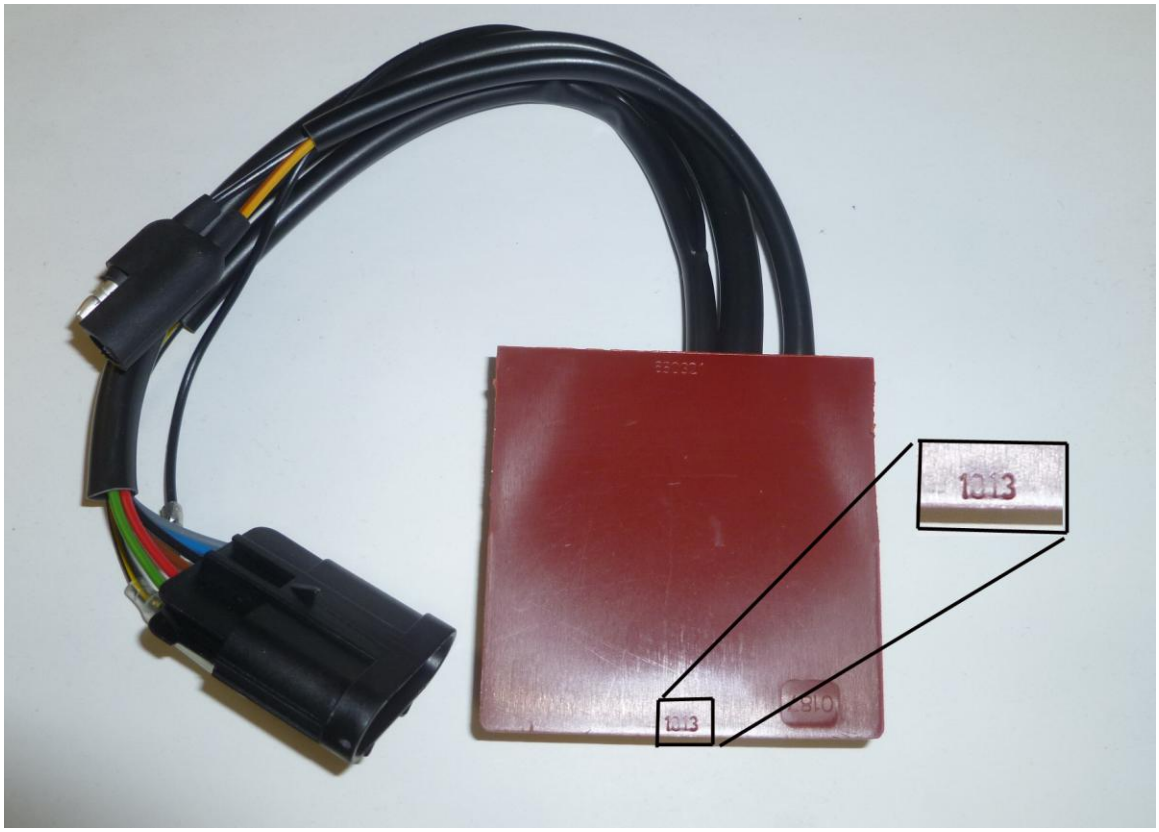
The 2014 CDI box can be identified by the date code. It will have a date code of "1013" (October 2013) or later as identified in the picture below.

The 2014 CDI unit for the Power Valve CX65 has improved ignition values that reduce or eliminate the high RPM 'popping' some have experienced in 2013. From this time forward the new 2014 box will be considered the standard service replacement for all CX65 power valve bikes from 2012 on.
