Technical Service Bulletin

Cobra Motorcycle Mfg.

TSB0110 Steering Stem Cap CX65

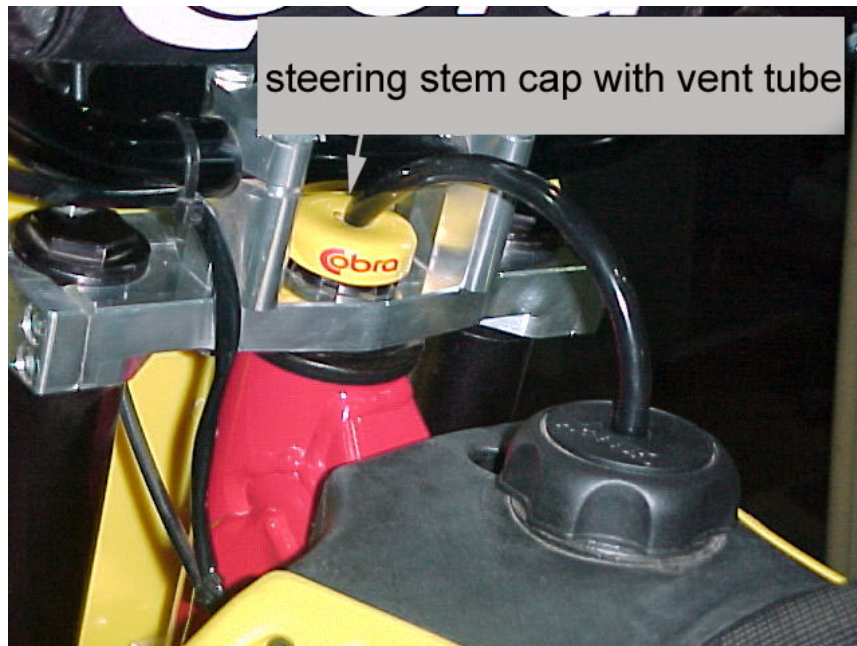
It is possible for water and dirt to accumulate in the steering stem of the Cobra CX65 after riding and washing. This mixture of dirt and water then can be siphoned into the vent tube or plug it off if the vent tube has sufficient length into the steering stem.

To avoid the accumulation of water and dirt into the steering stem, Cobra has introduced into production and has available a steering stem cap (FCMU0151) fits securely over the top of the steering stem jam nuts and has a hole to hold the vent tube.

This cap will also improve the useful life of the steering stem bearings.
