Technical Service Bulletin

Cobra Motorcycle Mfg.

TSB0504: 2004 King & CM50 water pump drive belt & pulley alignment & inspection.

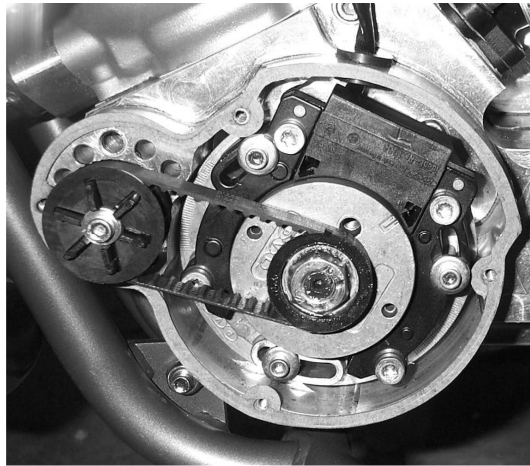
It is important to inspect three things on the water pump drive pulley and belt.

Inspect

1. That the belt and pulleys are in proper alignment and that the belt is not rubbing on flywheel or edges of the pulleys
2. That the pulleys are not cracked
3. That the water pump impeller pulley fastener is tight and has adequate high strength thread lock agent applied.

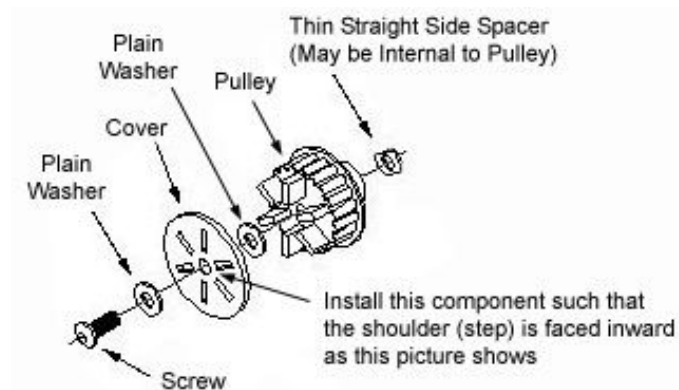
Below is the proper orientation of the water pump drive pulley, cover, and spacers.
